# Radon Measurement Report

Kerlin Home Inspections, LLC  
(205) 259-6020  
Contact@KerlinHomes.com  
6117 Amy Ln  
Trussville Alabama 35173

Location: Basement  
6117 Amy Ln  
Trussville AL 35173 Jefferson

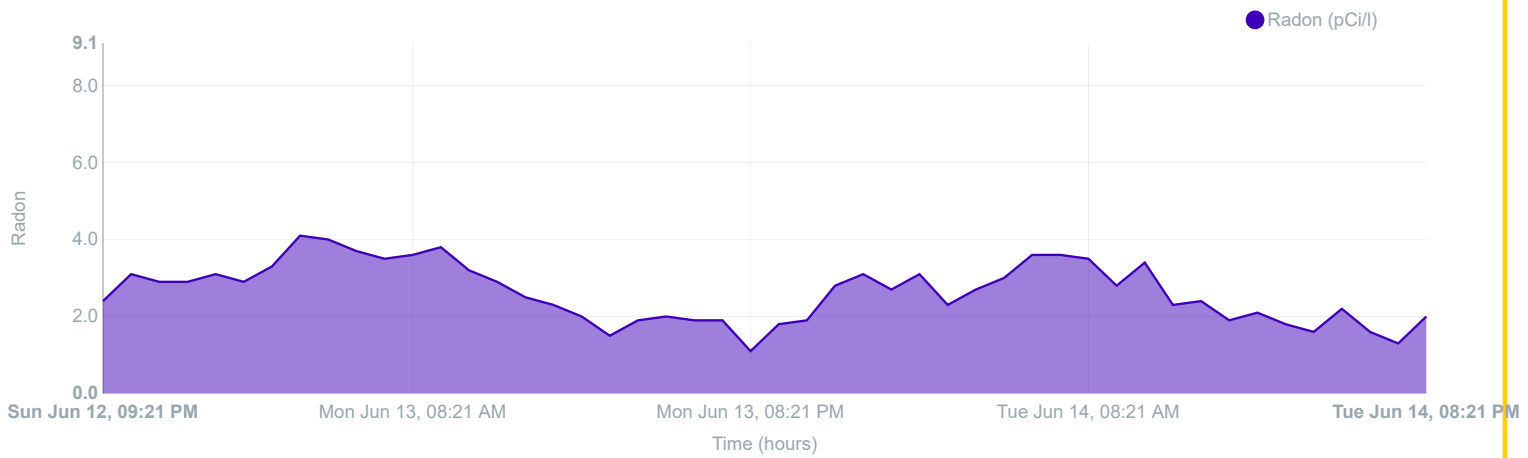
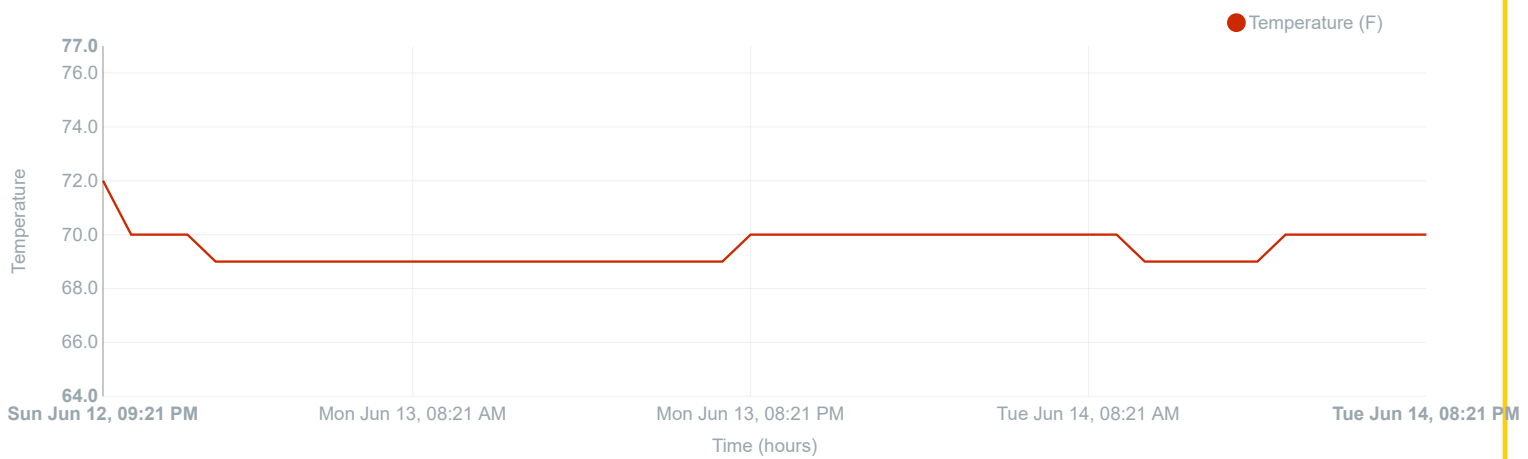
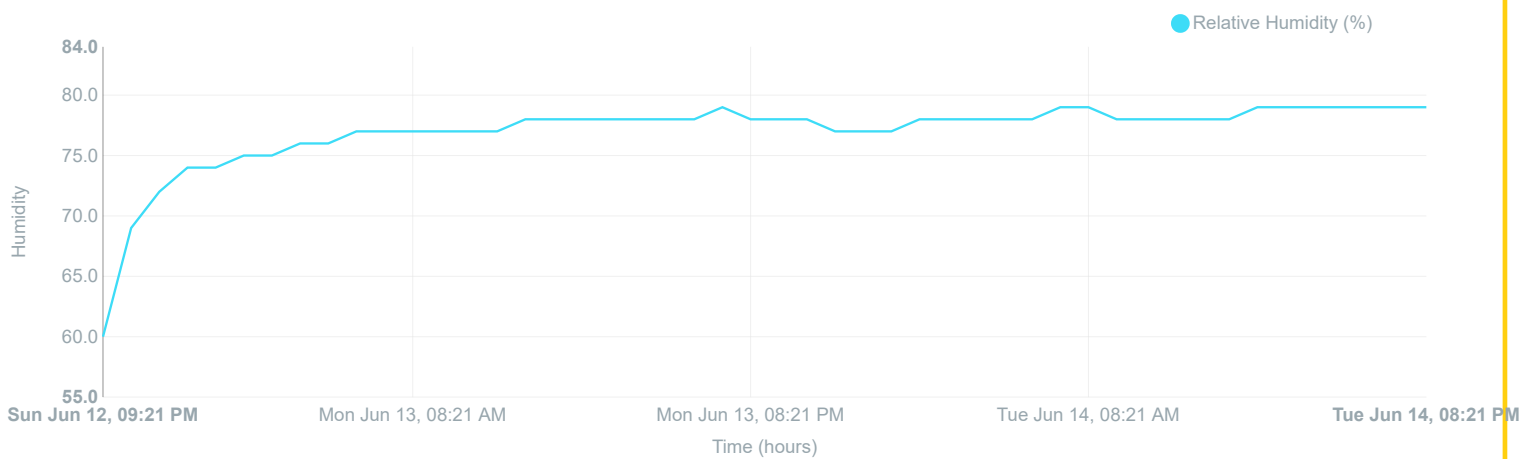
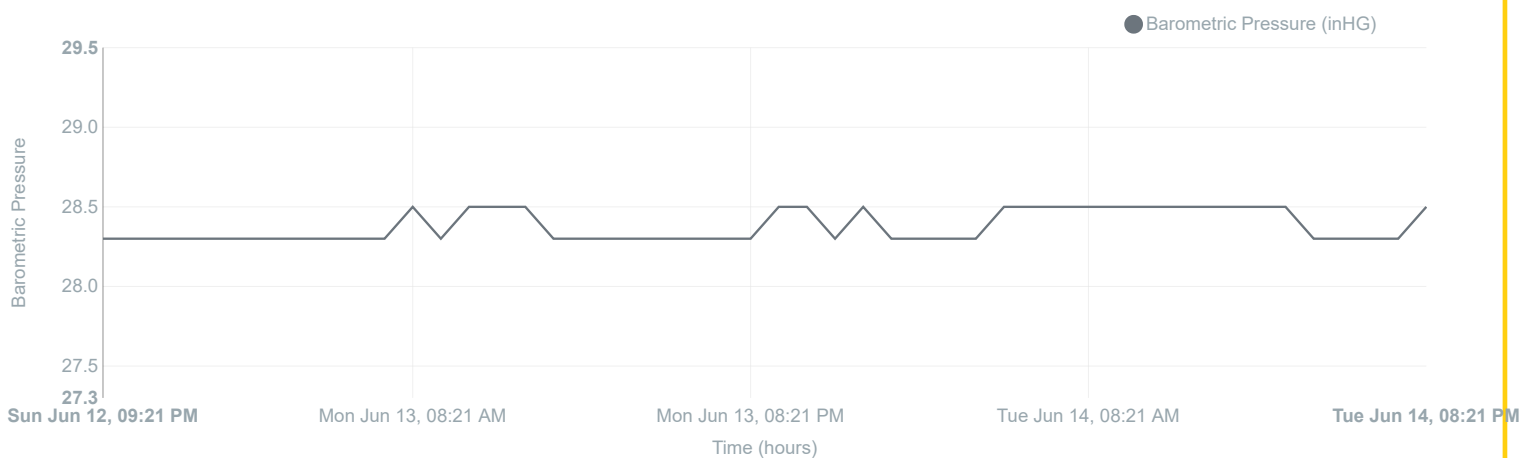
## Air Quality Graphing

Average Radon: 2.6 pCi/l

**Radon is near EPA action level.**

- Consider fixing the building if the test results indicate radon levels greater than half the action level.
- Tests conducted when heating systems are active both day and night are more likely to provide a clear characterization of potential radon hazards.
