INSPECTION REPORT  
1 Redacted Ln  
Trussville AL 35173

INSPECTED BY  
Austin Kerlin  
Kerlin Home  
Inspections

INSPECTION DATE  
📅 6/13/2022  
🕒 09:00 AM

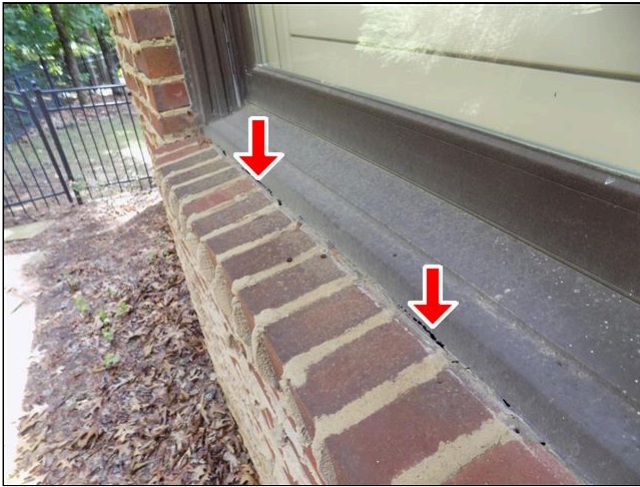
1.0 Item 1

**1.0** One or more of the windows were in need of caulking in some areas. Recommend repairs.

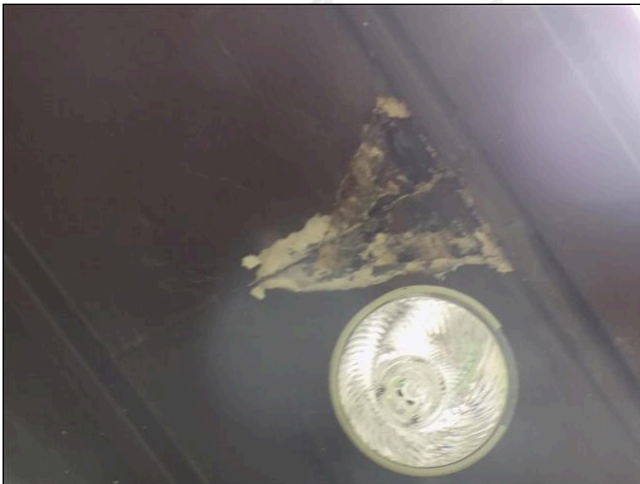
1.2 Item 1

**1.2 (1)** An area of soffit above the rear porch entrance had elevated moisture and deteriorated. Recommend further evaluation to locate and repair the leak.

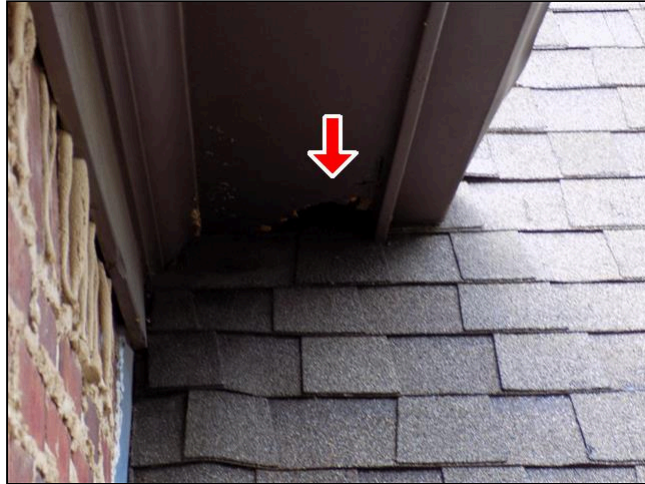
1.2 Item 3

1.2 (2) An area of soffit was damaged by the upstairs bedroom. A squirrel came running out when approached. Recommend having the nest removed and the opening repaired.

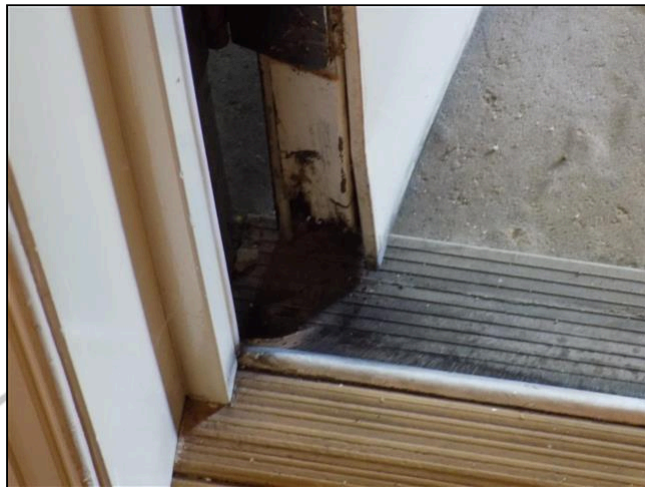
1.3 Item 1

1.3 Some damage to the basement patio door was observed. Recommend repairing or replacing as needed.

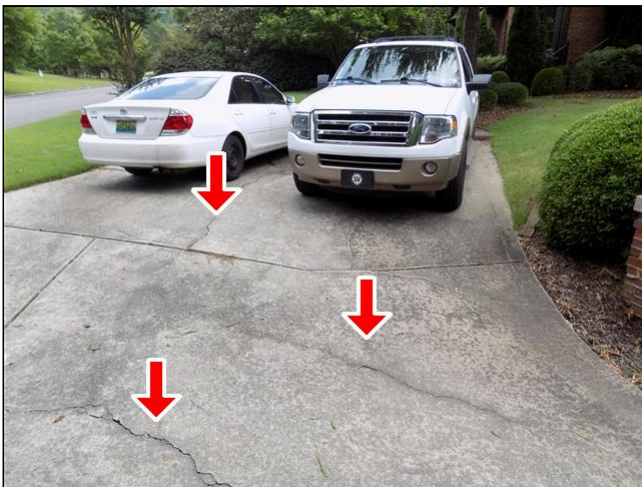
1.5 Item 1

1.5 (1) Some cracks were observed in the driveway that appeared to be stable. Recommended monitoring.

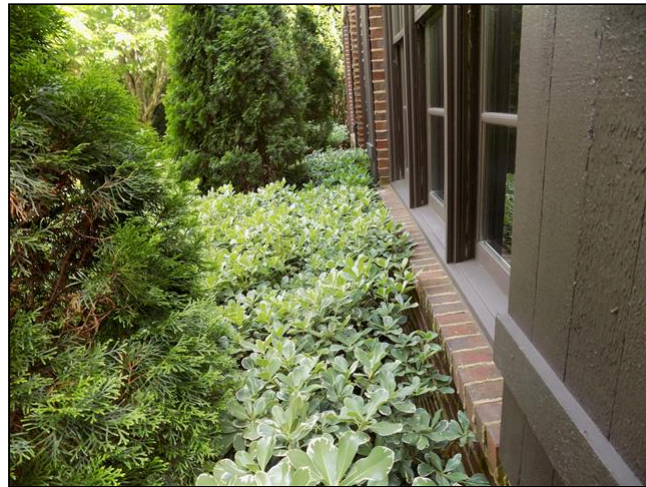
1.5 Item 3

**1.5 (2)** Plants in contact with the side of the house may damage the wall cladding material, allow pests a path of entry, and may cause moisture issues. Recommended clearing any vegetation in contact with or close proximity to the structure.

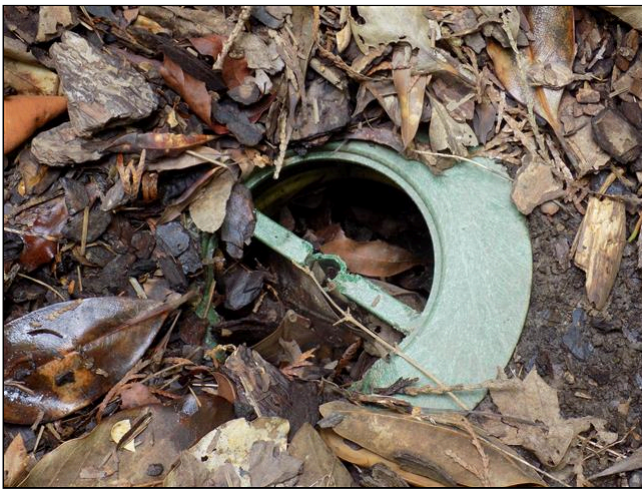
1.5 Item 4

**1.5 (3)** A pop up for the drainage system near the front left of the building is broken and full of debris. Recommend replacement and cleaning the drain line.

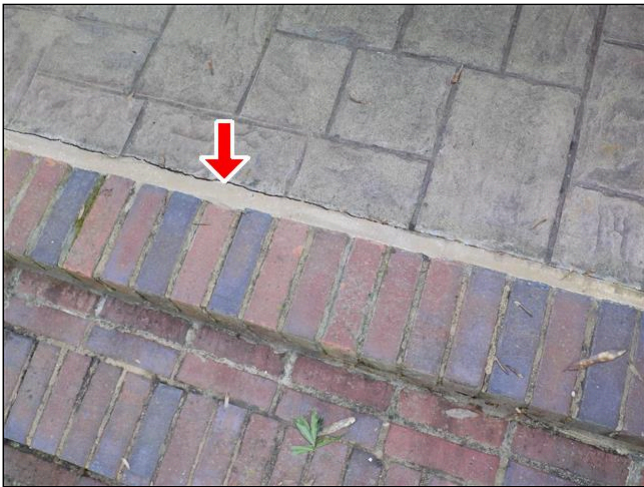
1.5 (4) Some movement of the stairs at the front stoop has caused the handrails to pull away from their original mounting locations. This movement may be due to poor drainage in the area. Recommend having the handrails secured, directing drainage further away from this area, and monitoring.

1.5 Item 8 Gap has been filled

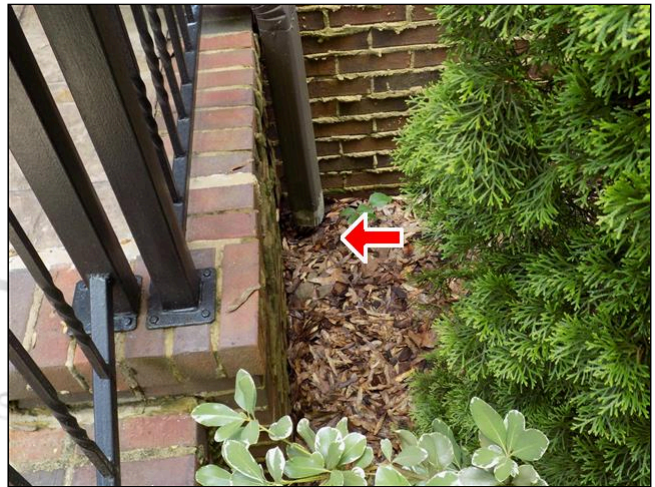
1.5 Item 9 poor drainage

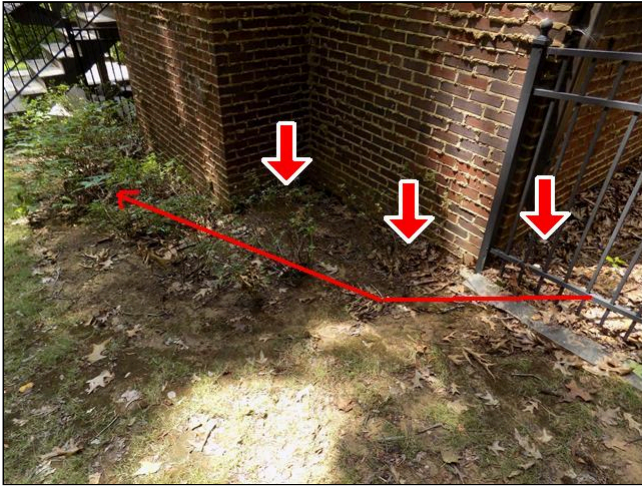
1.5 Item 11

1.5 (5) Recommend adding some dirt in this area and extending the downspout to improve drainage.

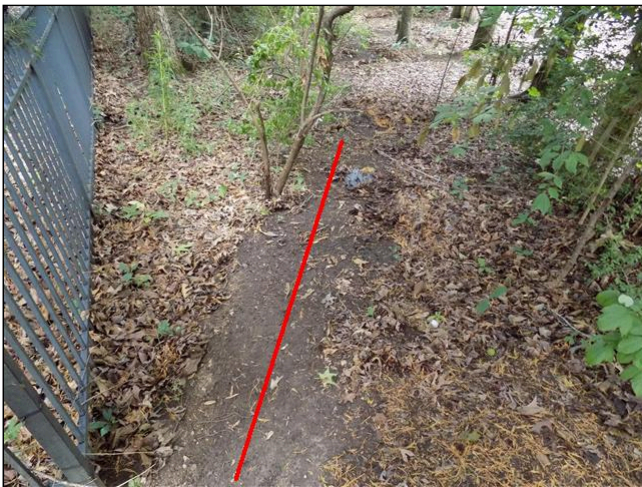
1.5 Item 13

1.5 (6) Some significant erosion was noted in the back right of the driveway area. Drainage may need to be controlled in this area.

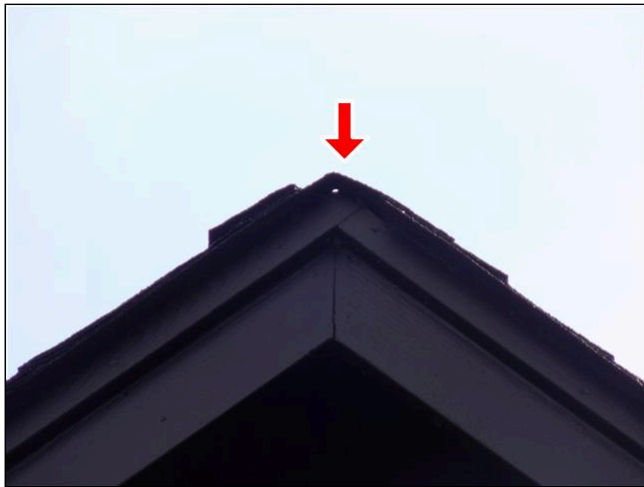
2.0 Item 1

**2.0 (1)** A number of ridge cap shingles were in need of replacement. They have cracked and light could be seen through them.

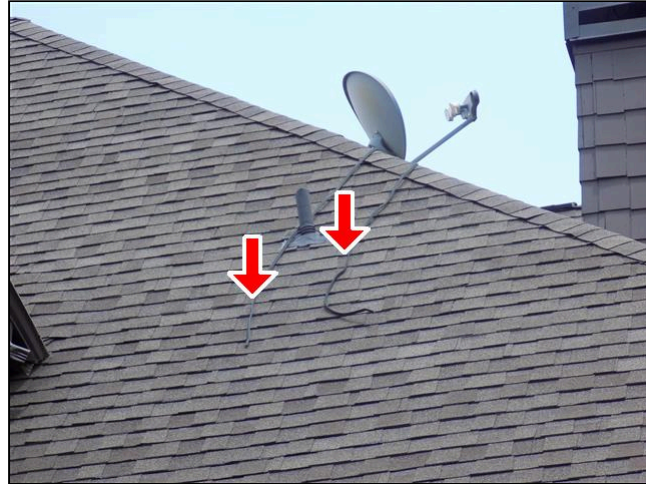
2.0 Item 6

**2.0 (2)** Some cables were present laying on the roof surface. They appeared to be unused satellite cables. Recommend having them removed.

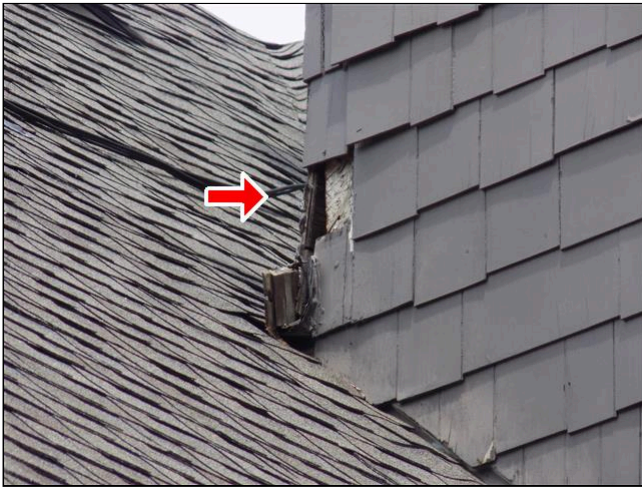
2.2 Item 1

**2.2** Several areas of chimney siding were in need of repair. There were multiple missing stakes and also what appeared to be insect damage. Recommend further evaluation and repairs.

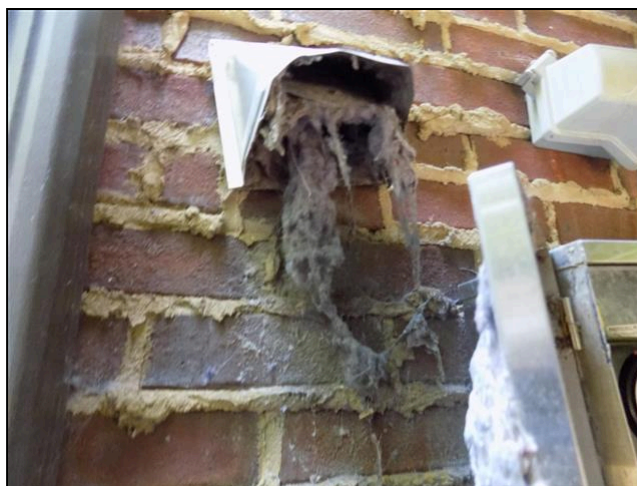
4.4 Item 1

**4.4** Excessive lint build up or fully clogged dryer vents impede dryer function and pose a fire hazard. Cleaning is strongly advised.

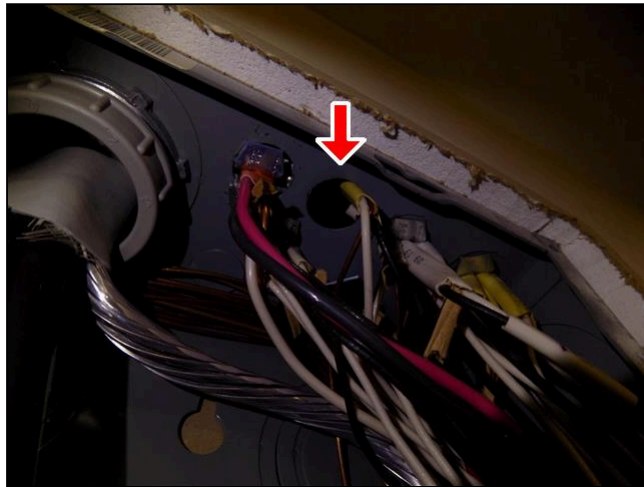
5.1 Item 1

**5.1** There were one or more missing bushings, clamps, or knockouts in the panel. Clamps or bushings secure the wire to the panel and prevent damage to the insulation. Missing knockouts may allow critters to enter the panel, which will likely end in their death, and possibly a fire. If outside, they may allow water to enter. Recommend repair.

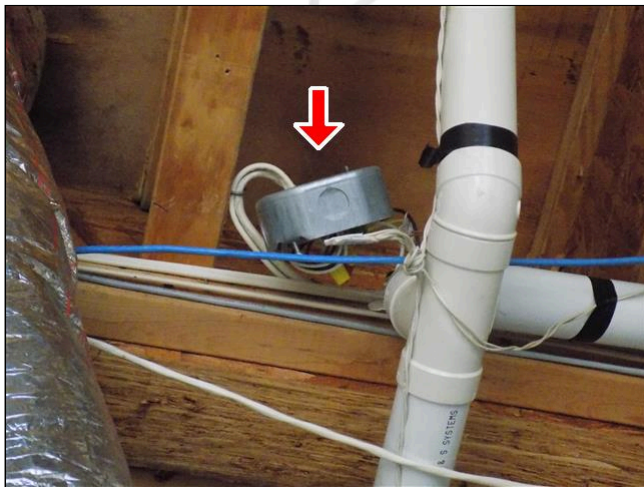
5.3 Item 1

**5.3 (1)** One or more exposed splices, conductors, or receptacles were observed.

Conductors should be enclosed in a junction box with a cover. Exposed conductors create a shock and electrocution hazard.

Recommend repairs by a qualified contractor.

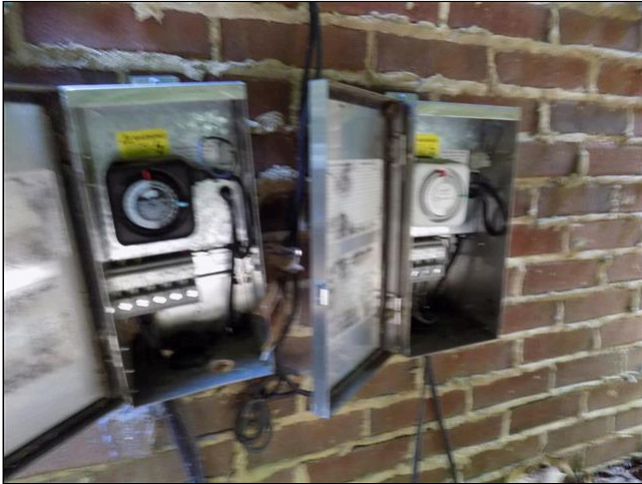
5.3 Item 3

5.3 (2) There are two low voltage enclosures on the exterior which are open and missing wire clamps. Recommend securing these closed and installing missing hardware.

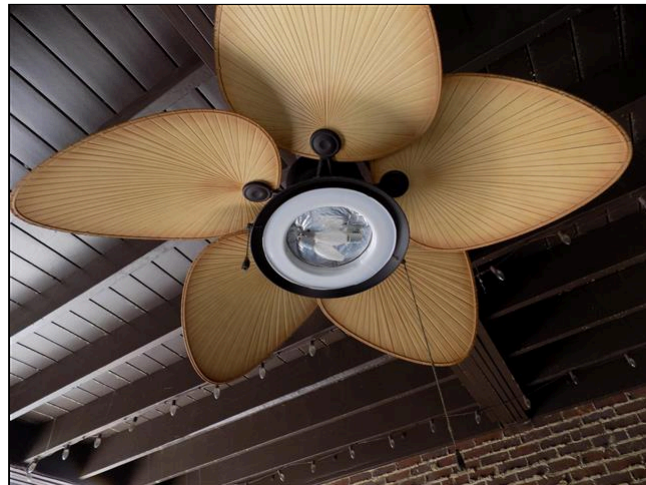
5.3 Item 6

5.3 (3) The fan was missing the light cover. Recommend replacement.

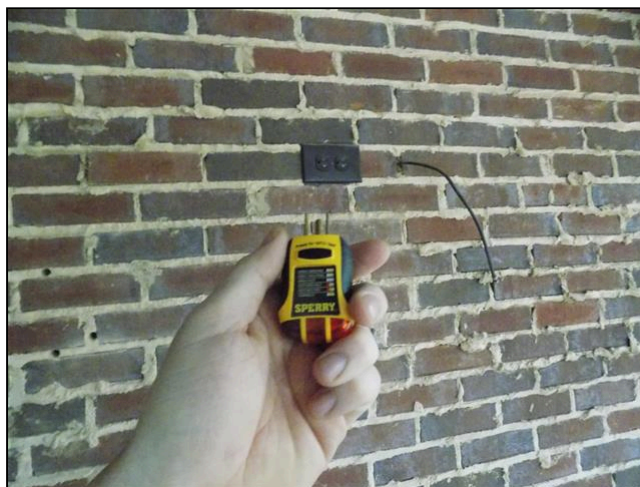
5.4 Item 1

**5.4** One or more receptacles that should be GFCI protected were not, or the device(s) failed to trip and reset properly, at the time of inspection. Recommend correction.

This outlet was located on the back patio wall.

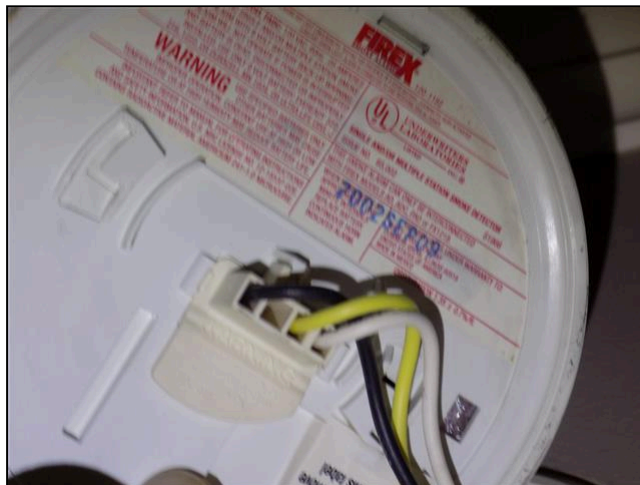
5.7 Item 1

**5.7** The smoke detectors were old or expired, recommend replacement.

The NFPA recommends installing smoke alarms in every sleeping room and outside each separate sleeping area, and on every level of the home. The NFPA also recommends alarms be supplied by the electrical system, interconnected with each other, and have a battery backup. Combination smoke / CO alarms are a great option. The NFPA recommends testing your alarms monthly and replacing them every 10 years.

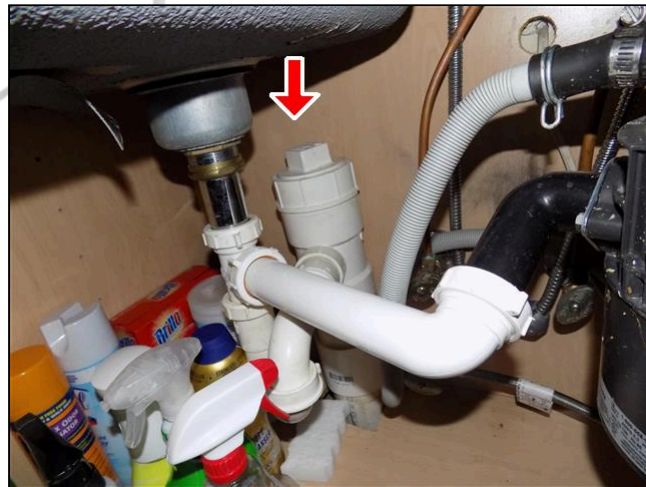
6.0 Item 1

**6.0** This plumbing configuration may need an air admittance valve installed. Recommend repair if needed.

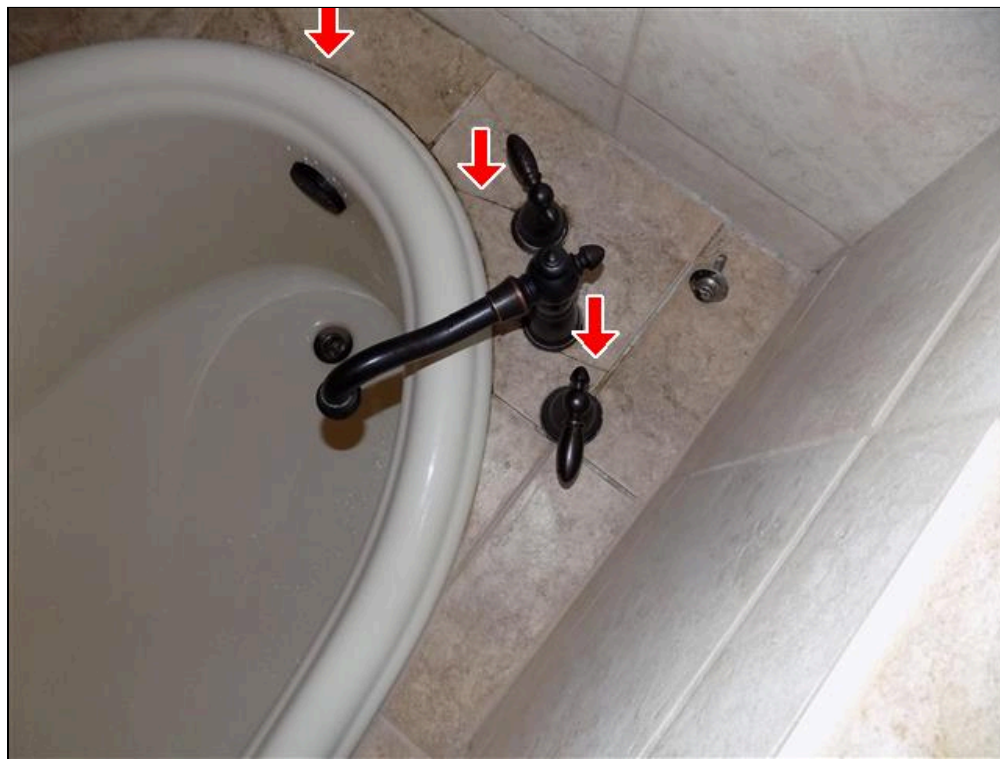
6.1 Item 2

**6.1 (2)** A number of tiles are cracked or loose surrounding the guest bath tub, and the faucet is loose. Recommend repairs.

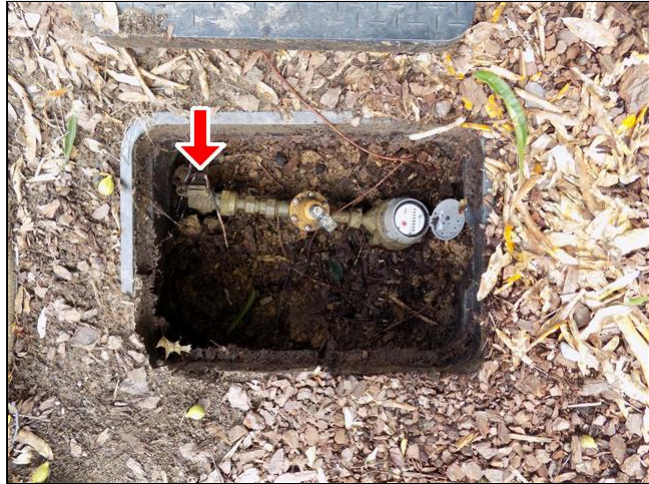
6.3 Item 1

**6.3** The main water shutoff is located outside at the water meter.

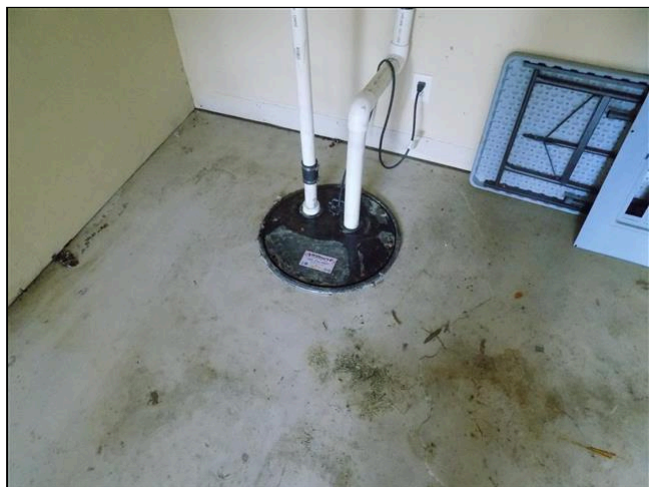
6.6 Item 1

**6.6 (1)** The sump pump did not operate and the tank overflowed during the inspection. The sump pump is in need of service.

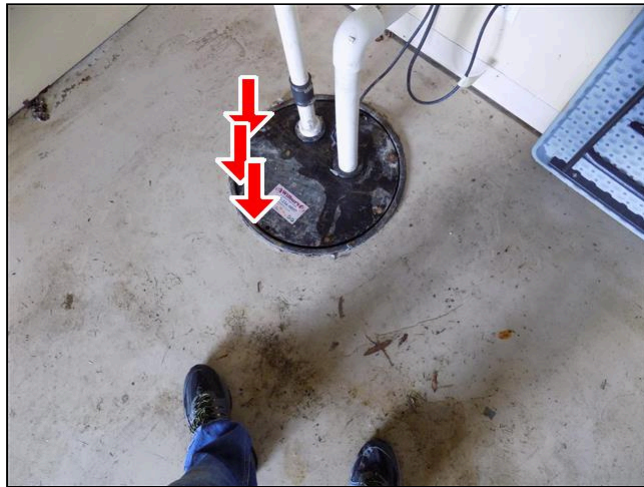
6.6 Item 2

**6.6 (2)** The sump pump is missing a number of fasteners from the lid. Recommend having these installed when the pump is serviced.

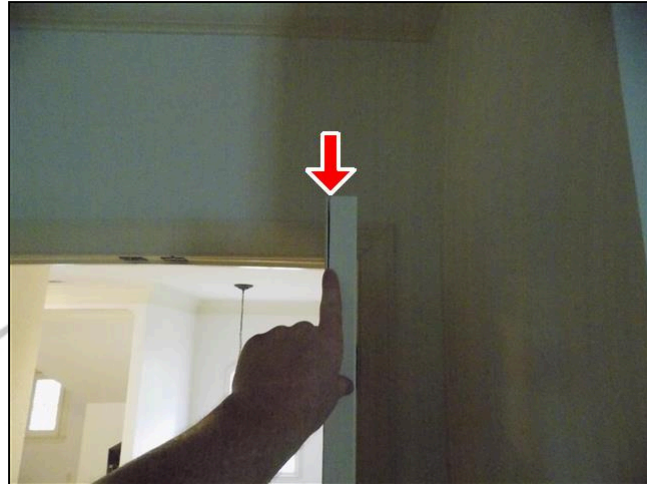
7.5 Item 3

7.5 (2) A bedroom door was beginning to delaminate. Recommend repair as needed.

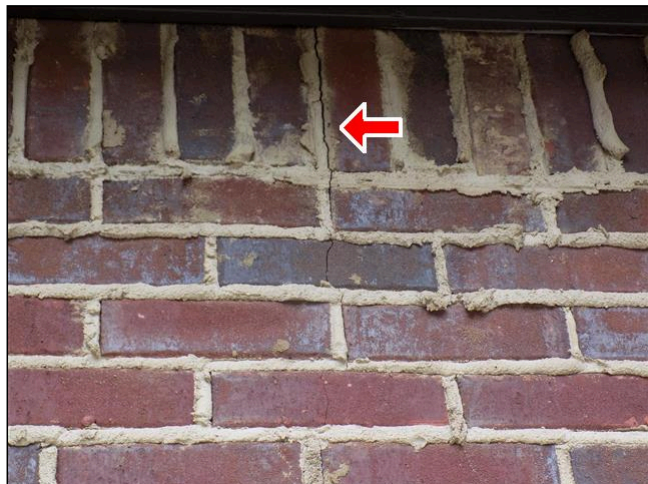
10.1 Item 1

**10.1** Some cracks were observed in the brick veneer. Recommend monitoring.

Common areas for cracks to develop include over garage doors, at the corners of doors, corners of windows, the corners of block walls, etc. Settlement is a common cause of cracking. Typically fine cracks are not a concern but should be monitored, provided they are not allowing water to enter the building.

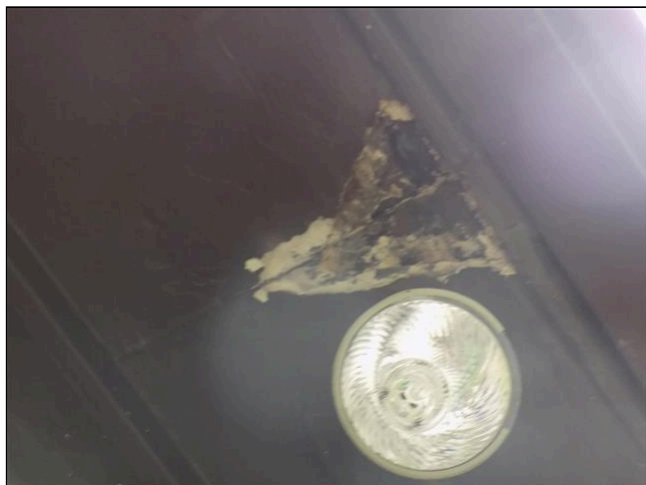
1.2 Item 1

(1) An area of soffit above the rear porch entrance had elevated moisture and deteriorated. Recommend further evaluation to locate and repair the leak.

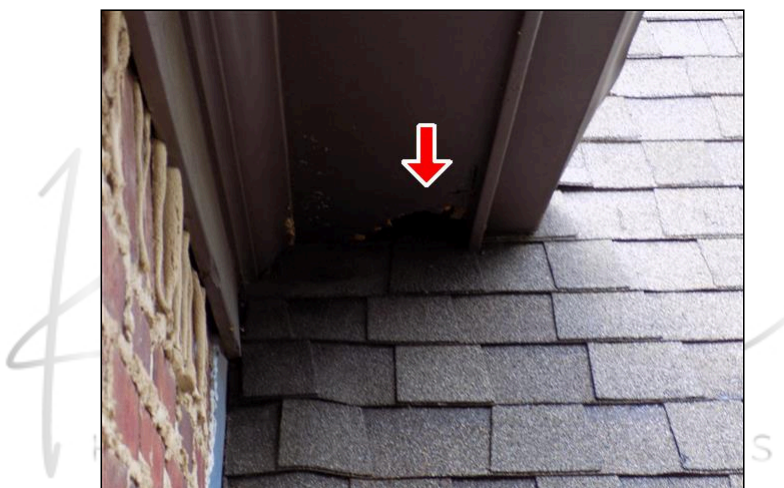
1.2 Item 3

(2) An area of soffit was damaged by the upstairs bedroom. A squirrel came running out when approached. Recommend having the nest removed and the opening repaired.

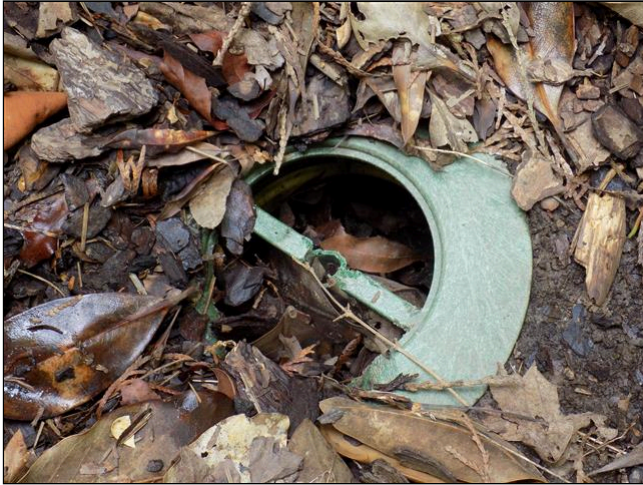
1.5 Item 4

(3) A pop up for the drainage system near the front left of the building is broken and full of debris. Recommend replacement and cleaning the drain line.

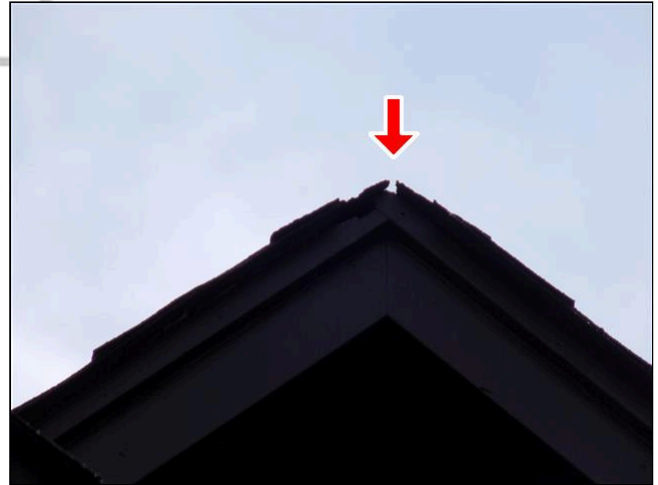
2.0 Item 2

(1) A number of ridge cap shingles were in need of replacement. They have cracked and light could be seen through them.

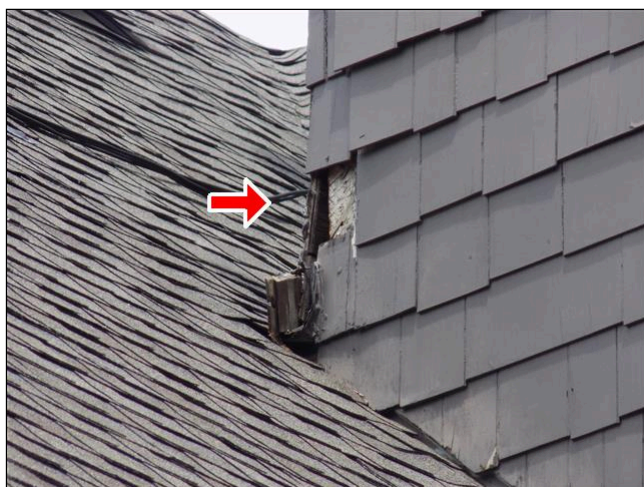
2.2 Item 1

Several areas of chimney siding were in need of repair. There were multiple missing stakes and also what appeared to be insect damage. Recommend further evaluation and repairs.

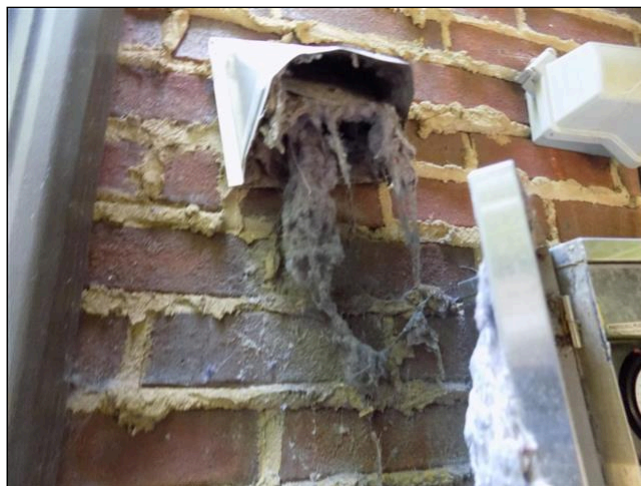
4.4 Item 1

Excessive lint build up or fully clogged dryer vents impede dryer function and pose a fire hazard. Cleaning is strongly advised.

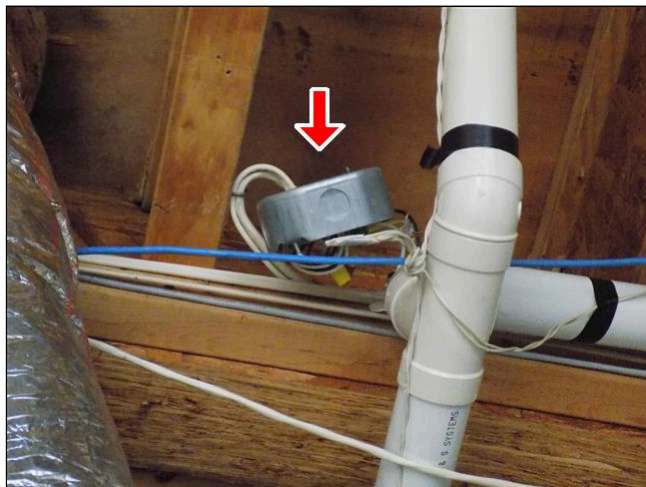
5.3 Item 1

(1) One or more exposed splices, conductors, or receptacles were observed.

Conductors should be enclosed in a junction box with a cover. Exposed conductors create a shock and electrocution hazard.

Recommend repairs by a qualified contractor.

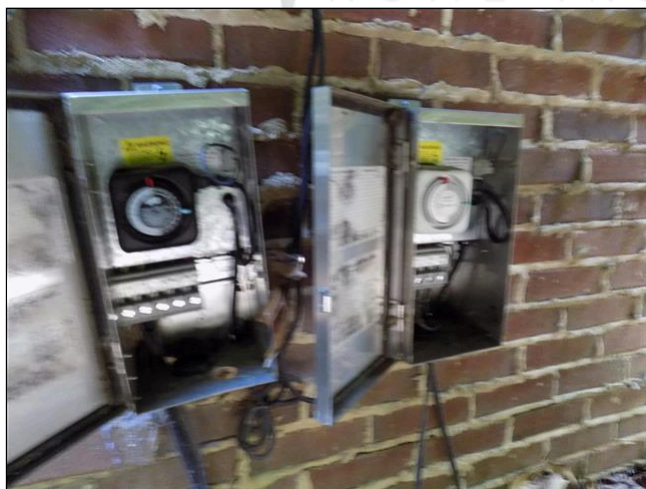
5.3 Item 3

(2) There are two low voltage enclosures on the exterior which are open and missing wire clamps. Recommend securing these closed and installing missing hardware.

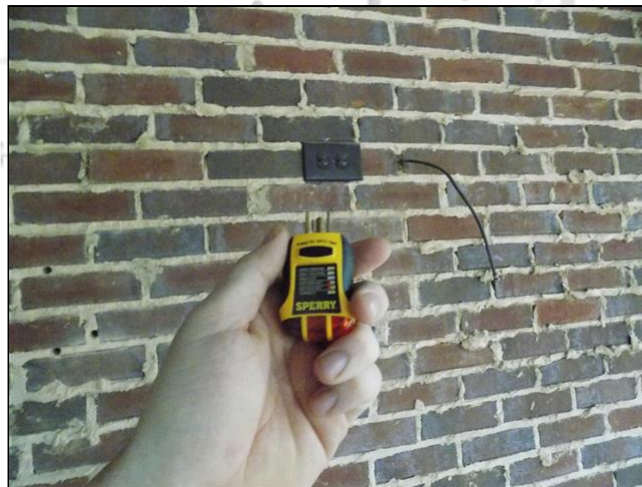
5.4 Item 1

One or more receptacles that should be GFCI protected were not, or the device(s) failed to trip and reset properly, at the time of inspection. Recommend correction.

This outlet was located on the back patio wall.

GFCI protection is required in many areas of the home: bathrooms, garages, outdoor receptacles, crawl spaces, basements, kitchens and anything within six feet of a sink or water source. GFCI protection can be provided by installing GFCI receptacles or breakers.

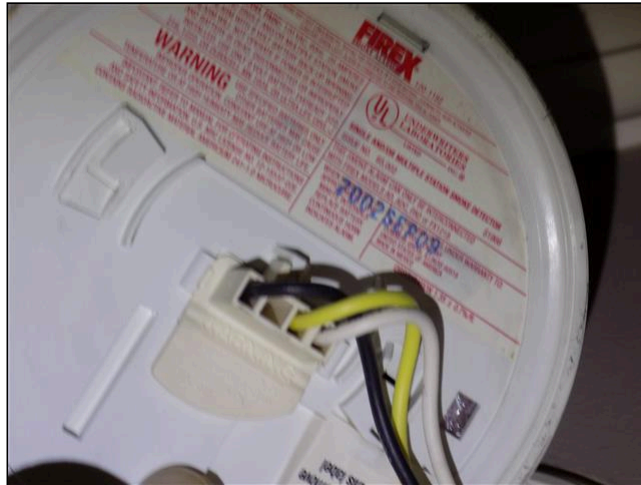
5.7 Item 1

The smoke detectors were old or expired, recommend replacement.

The NFPA recommends installing smoke alarms in every sleeping room and outside each separate sleeping area, and on every level of the home. The NFPA also recommends alarms be supplied by the electrical system, interconnected with each other, and have a battery backup. Combination smoke / CO alarms are a great option. The NFPA recommends testing your alarms monthly and replacing them every 10 years.

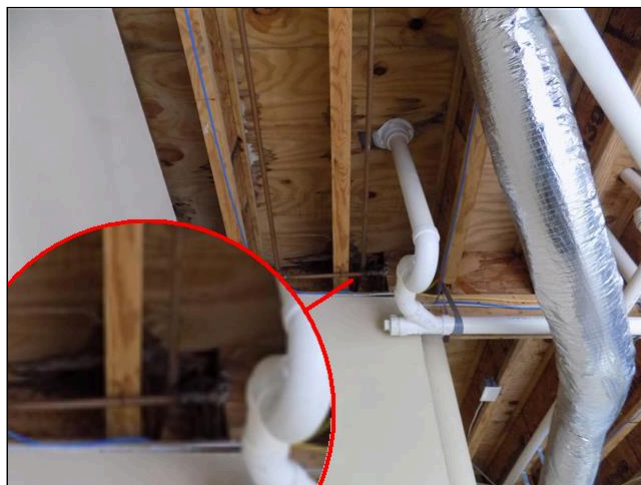
6.1 Item 1

(1) Elevated moisture levels were present under the master shower area. Recommend further evaluation and repairs as needed.

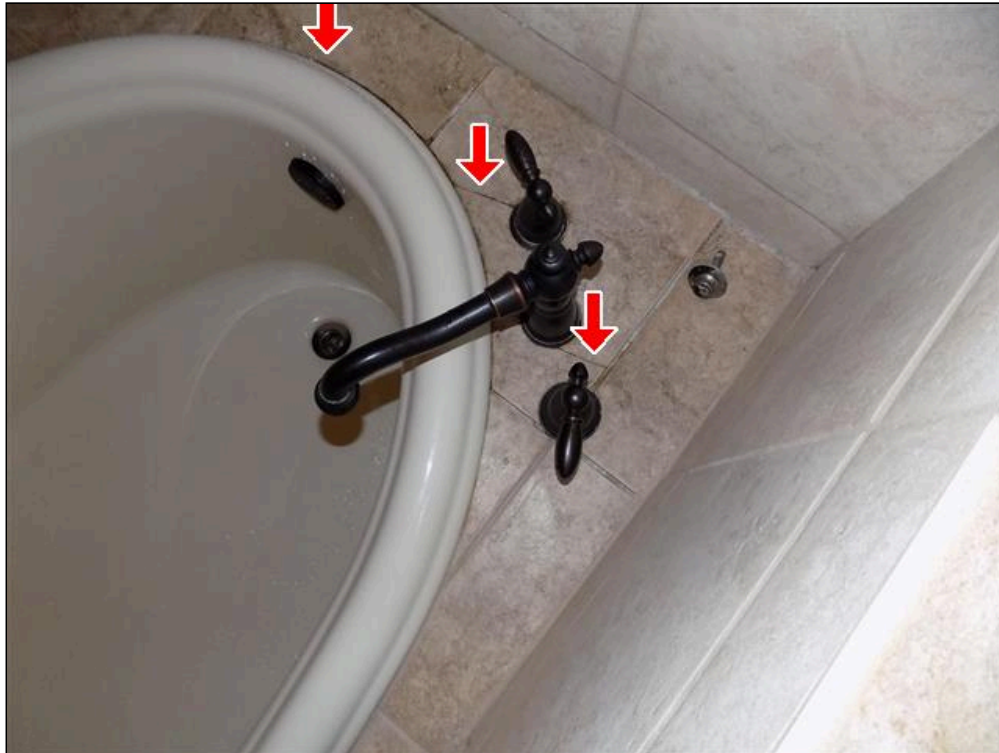
6.1 Item 2

(2) A number of tiles are cracked or loose surrounding the guest bath tub, and the faucet is loose. Recommend repairs.
